## Inspection Report Minerals Regulatory Program February 20, 2013

<b>Mine Name:</b> Kennecott Tailings	<b>Permit Number:</b> M/035/0015
<b>Operator Name:</b> Kennecott Utah Copper	<b>Inspection Date:</b> March 10, 2011
<b>Inspector(s):</b> L Heppler, P Brinton	<b>Time:</b> 2:00 pm
<b>Other Participants:</b> Zeb Kenyon - Kennecott	<b>Mine Status:</b> Active

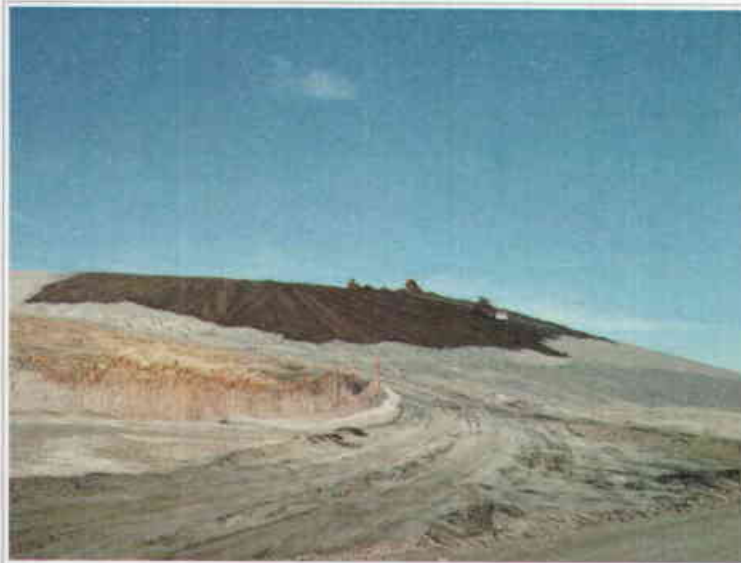
Spreading Topsoil on North Tailings

**Conclusions and Recommendations:** OGM recommends continuing new topsoil program on final slopes and working on biodiversity of vegetation. OGM to continue annual inspections and monitor the site when in the area.
